AFRL-PR-WP-TR-1998-2110

THIN DENSE CHROME BEARING INSERTION PROGRAM

Pyrowear 675 and Cronidur Wear Testing

OCTOBER 1998

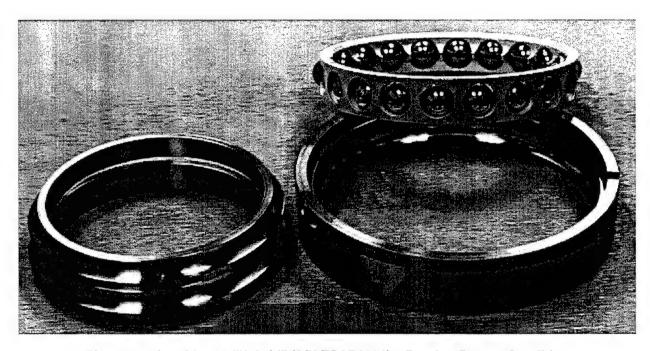
Figure 2. Cronidur 30 "Hybrid" (S/N FCAB0971) - Bearing Pretest Condition

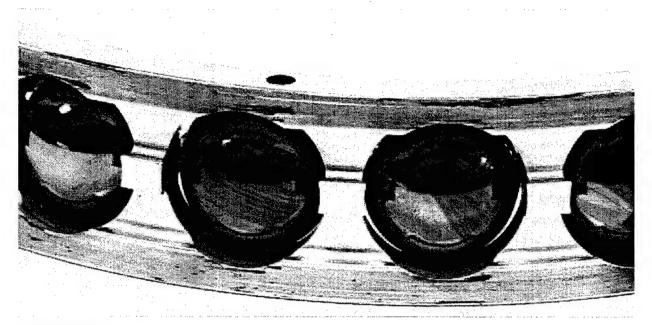
Both bearings showed similar evidence of wear initiation. The balls had scratches, and some could be felt with a 0.030-inch radius scribe. The cage rail outer surfaces had circumferential scratches and local dark streaks. The cage pockets had aluminum oxide imbedded in the silver. The outer raceway curvatures had some pitting and denting on the puller groove side (the loaded side). The outer race shoulders showed some circumferential polishing. The inner raceway also had pitting and denting on the loaded half. Figures 3 and 4 show the bearings at this midtest point.

Figure 3. Cronidur 30 "Purebred" Cage and Ball Midtest Wear

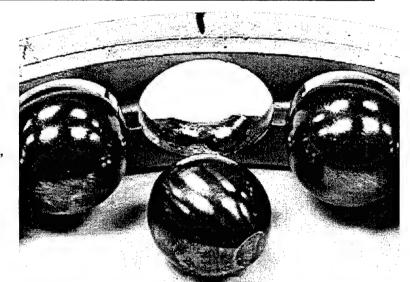
At teardown, the condition of the two bearings was reviewed. Several balls in one bearing, S/N FCAA7068, were severely worn — the worst ball being ellipsoid in shape. Table 2 lists ball diameter measurements. A few balls had debris denting. The second bearing, S/N FCAA7069, did not experience this severe wear but did have scratches on the balls. The cage rail outer surfaces had local dark streaks. The outer race of both bearings had some wear on the cage guiding shoulders. The outer race shoulders were measured before and after the test to reveal a radial wear depth of 0.001 inch. The loaded half of the inner race had fine pitting and denting. The raceway-to-shoulder corner appears distorted and raised. Figures 5 through 14 show the posttest "purebred" bearings.

Diameter, in			
Ball No.	Pretest	Posttest, Major	PostTest, Minor	Radial Wear Depth, in
1	0.875	0.869	0.784	0.0455
2	0.875	0.866	0.861	0.0070
3	0.875	0.868	0.842	0.0165
4	0.875	0.869	0.864	0.0055
5	0.875	0.868	0.865	0.0050

Figure 5. Cronidur 30 "Purebred" (S/N FCAA7068) Ball Ellipsoidal Wear

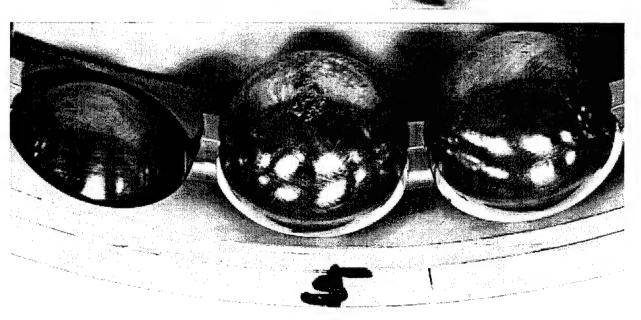
Figure 6. Cronidur 30 "Purebred" (S/N FCAA7068) Ball Debris Denting

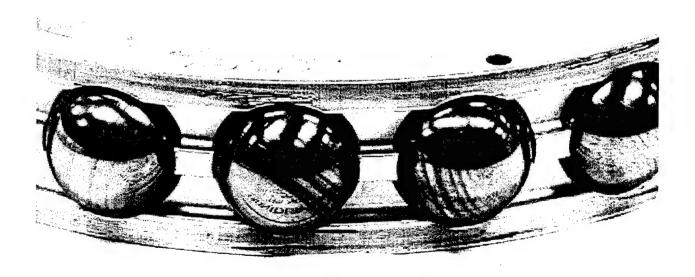
Figure 8. Cronidur 30 "Purebred" (S/N FCAA7069) Cage and Ball Wear

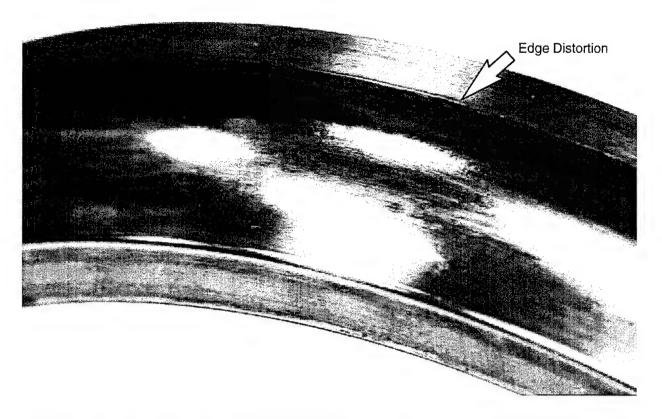
Figure 9. Cronidur 30 "Purebred" (S/N FCAA70680) Inner Race (Loaded Half) Posttest Condition

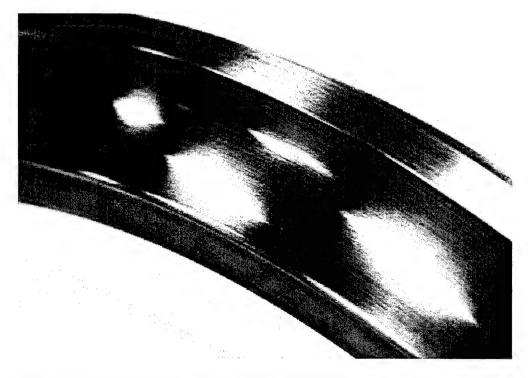
Figure 10. Cronidur 30 "Purebred" (S/N FCAA7068) Inner Race (Unloaded Half) Posttest Condition

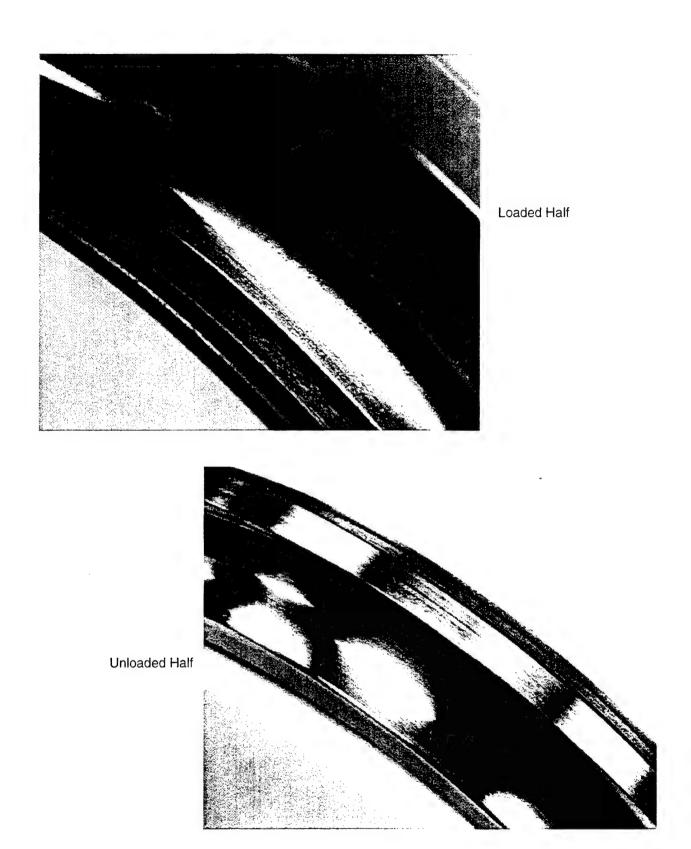
Both bearings had shoulder wear to a depth of 0.001 inch on the outer race shoulders, and both had the local dark streaks on the cage rail outer surfaces. The excessive damage to the balls was a concern. Both bearings were subjected to material evaluation to further examine the microstructure. The wear characteristic of the Cronidur 30 "purebred" bearing was deemed unacceptable.

Figure 11. Cronidur 30 "Purebred" (S/N FCAA7069) Inner Race Posttest Condition

Figure 12. Cronidur 30 "Purebred" (S/N FCAA7068) Outer Race Shoulder Wear

Figure 13. Cronidur 30 "Purebred" (S/N FCAA7069) Outer Race Shoulder Wear

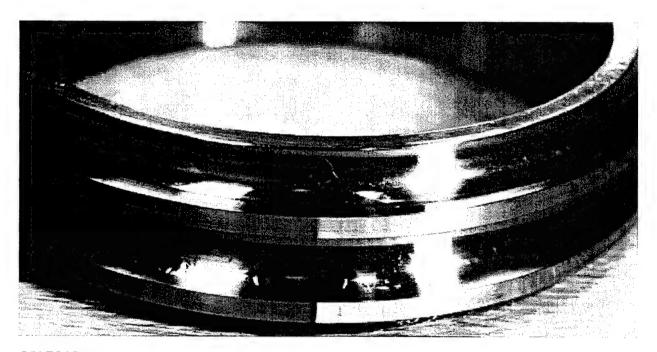
S/N FCAB0972

Figure 15. Cronidur 30 "Hybrid" Inner Race Shoulder Wear

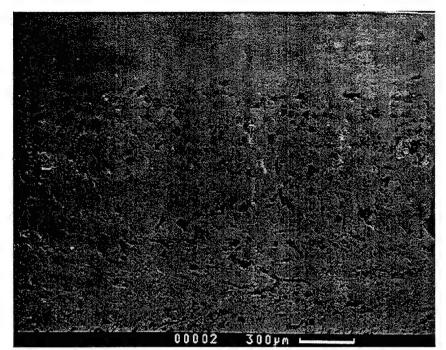
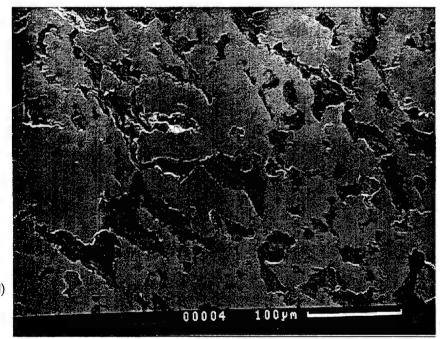
Figure 16. Cronidur 30 "Hybrid" Inner Raceway Microspalling (Page 1 of 3)

Figure 16. Cronidur 30 "Hybrid" Inner Raceway Microspalling (Page 2 of 3)

Figure 16. Cronidur 30 "Hybrid" Inner Raceway Microspalling (Page 3 of 3)

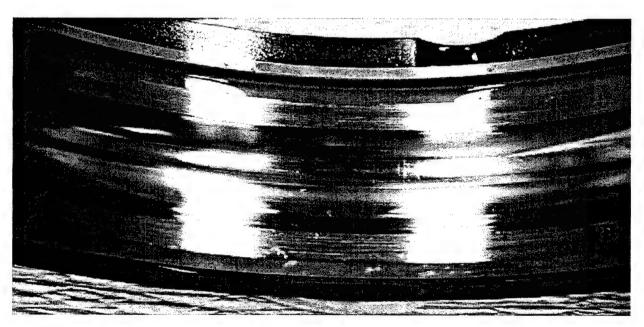
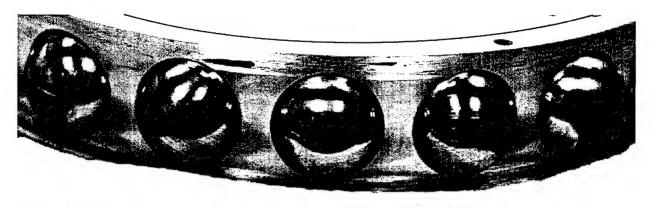
Both bearings had shoulder wear as indicated by light polishing and fine scratches on the outer race shoulders and local dark streaks on the cage rail outer surfaces. Both bearings underwent material evaluation to further examine the microstructure. The wear characteristic of the Cronidur 30 "hybrid" bearing was deemed unacceptable.

Figure 17. Cronidur 30 "Hybrid" Outer Race Shoulder Wear

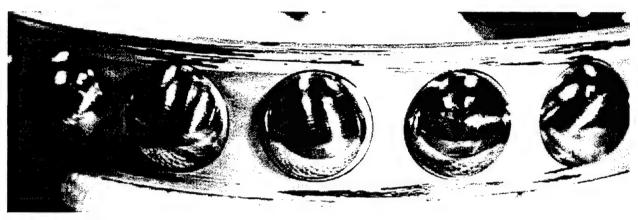
Figure 18. Cronidur 30 "Hybrid" Cage and Ball Wear

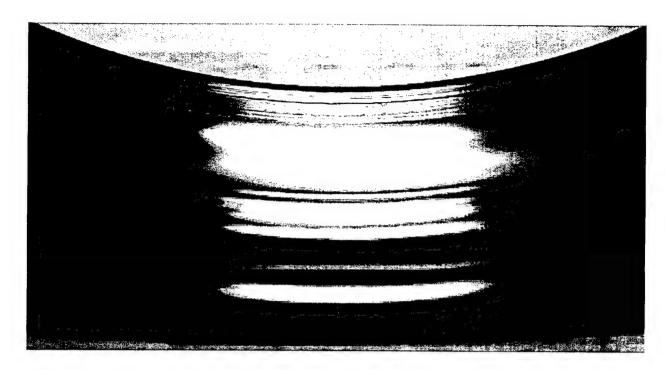
S/N MDAGK040

Both bearings had shoulder wear as indicated by the severe wear on the outer race cage guiding shoulders and cage rail outer surfaces. The bearings underwent material evaluation to further examine the microstructure. The wear characteristic of the Pyrowear 675 "hybrid" bearing was deemed unacceptable.

Figure 19. Pyrowear 675 "Hybrid" Outer Race Shoulder Wear

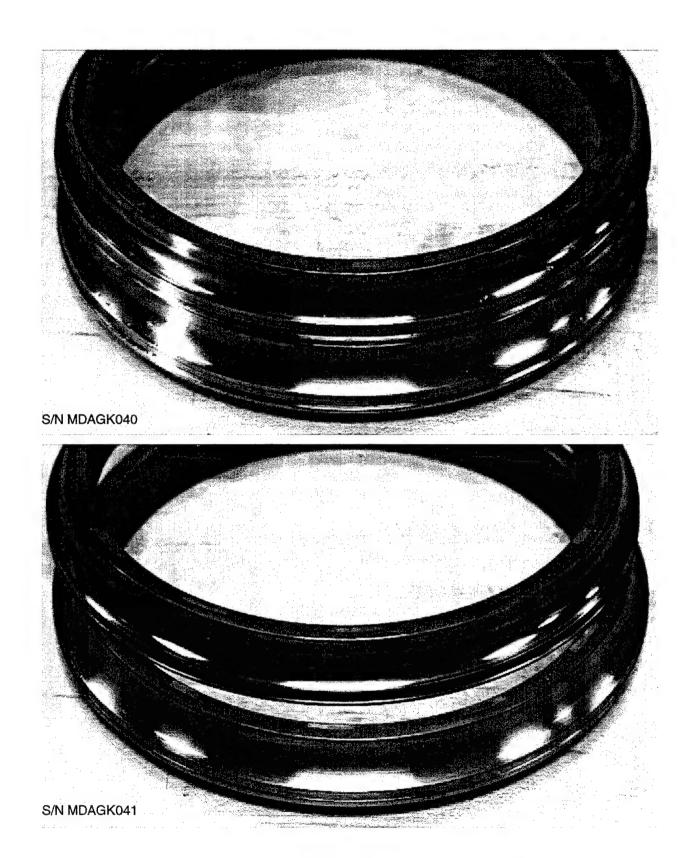
Figure 20. Pyrowear 675 "Hybrid" Inner Race Shoulder Wear

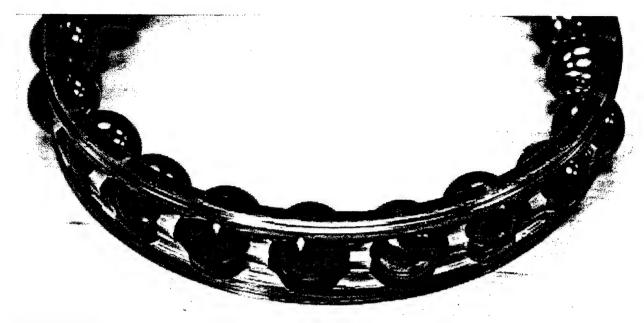
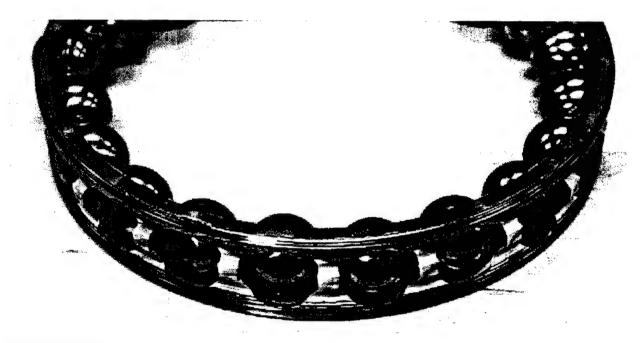
Figure 21. Pyrowear 675 "Hybrid" Cage and Ball Wear

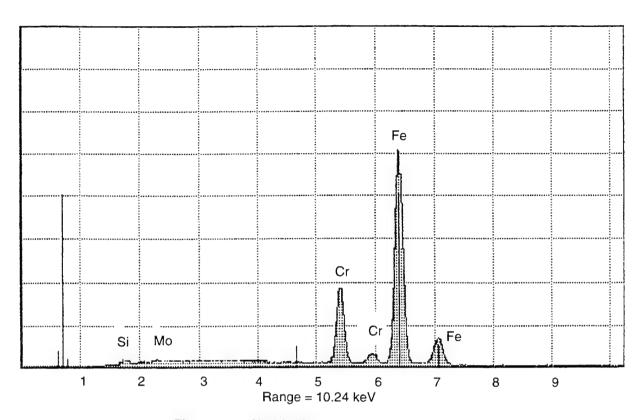
Microstructure analyses of radial cut sections of the bearing races compared the microstructures of Cronidur 30 and Pyrowear 675. The Cronidur 30 microstructure consisted of very fine-grain martensite and was void of eutectic carbides. Fine nitrides are visible in the microstructure at 500× in Figure 23. The electron-dispersive spectra (EDS) are illustrated in Figure 24.

Figure 24. SEM EDS of Cronidur 30 Inner Race

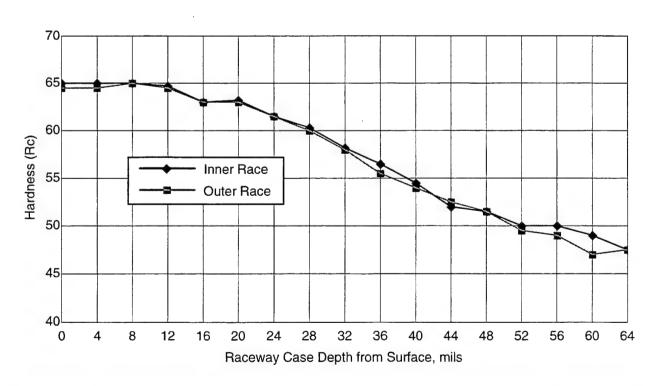
Measurement of the Pyrowear 675 material hardness showed case depth to be consistent with the typical requirements for a 3B bearing made of M50NiL. Figure 29 shows carburized case depth in the inner raceway, and Figure 30 is a plot of the microhardness measurements (inner and outer races).

Figure 30. Microhardness Case Depth Profiles of Outer and Inner Races Following Pyrowear 675 Contamination-Endurance Test

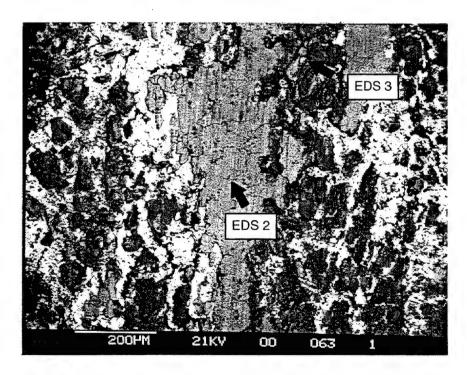
Figure 36. SEM Photograph of Bearing Cage Outer Diameter (110X)

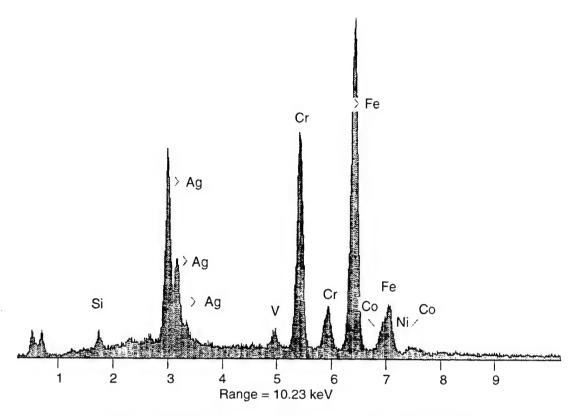
Pyrowear 675 and mechanically alloyed particles rich in chromium and vanadium (Figures 35 through 39).

Figure 37. EDS Signature of Frame Analysis of Fig. 36

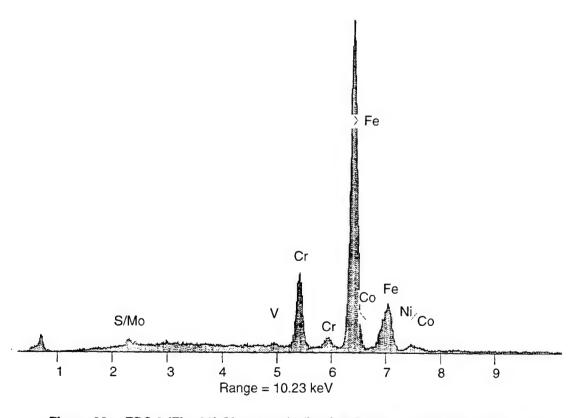
Figure 38. EDS 2 (Fig. 36) Signature Indicating Pyrowear 675 Wear Particles

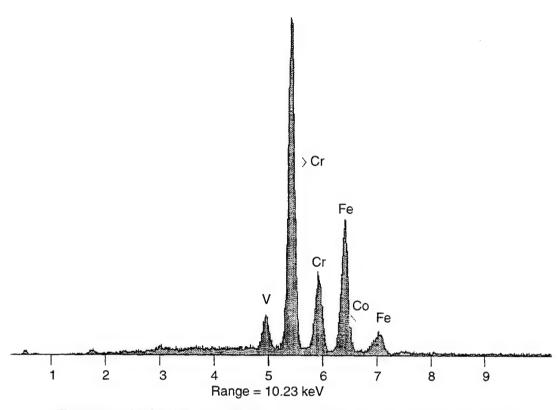
Figure 39. EDS 3 (Fig. 36) Signature Indicating Elevated Chromium and Vanadium in the Wear Product with Reduced Iron Content

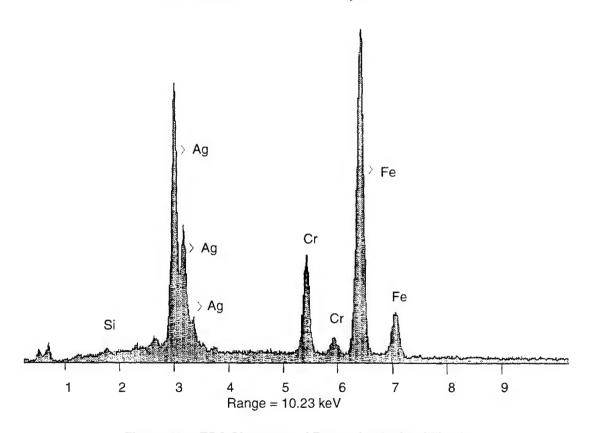
Figure 42. EDS Signature of Frame Analysis of Fig. 41

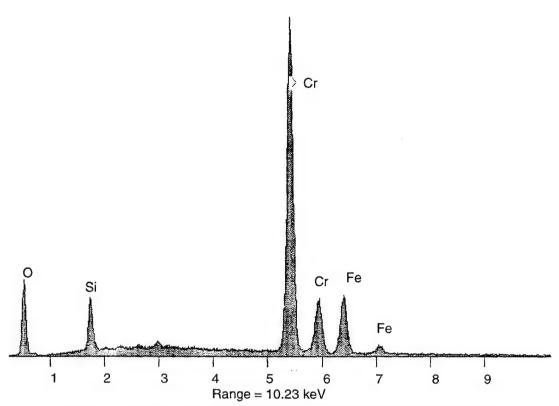
Figure 43. EDS 2 (Fig. 41) Signature Showing Elevated Chromium, Silicon, and Oxygen in the Wear Product

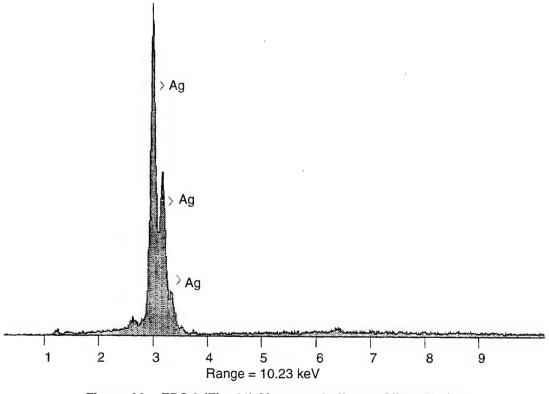
Figure 44. EDS 3 (Fig. 41) Signature Indicates Silver Plating

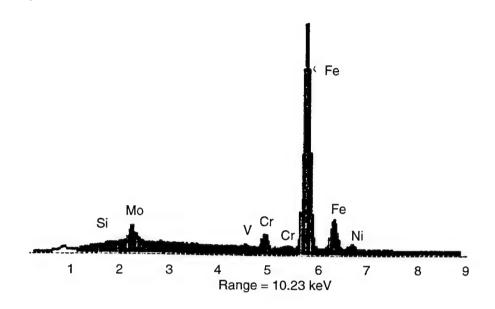
Figure 46. EDS Spectra for Cage Land Wear Products Typical of M50NiL

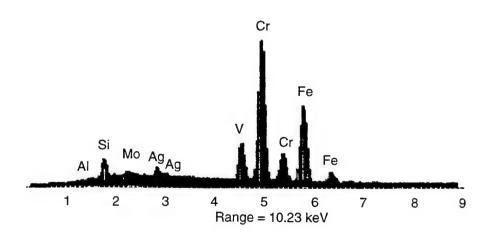
Figure 47. EDS Spectra Showing High Cr, Si, and V Wear Debris

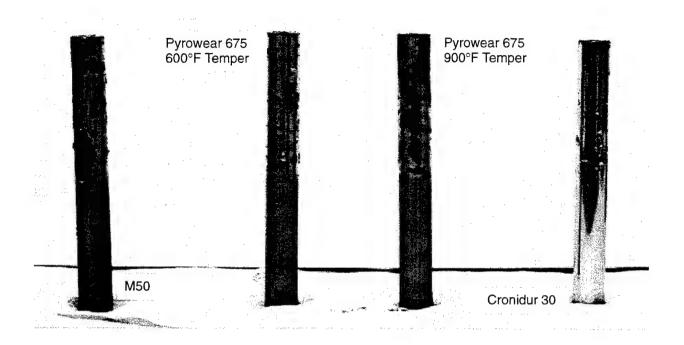
After 23 days of exposure, the M50 specimen was almost covered in corrosion, and the Pyrowear 675 specimens displayed a fair amount of corrosion. The Cronidur 30 material, on the other hand, was showing very little corrosion. The 600°F tempered Pyrowear 675 still exhibited less corrosion than the 900°F tempered Pyrowear 675 specimens in the tap water solution. Figures 48 and 49 show the specimens after 23 days of exposure in tap water and synthetic sea water solutions, respectively.

Figure 48. Corrosion Resistance Test: Tap Water

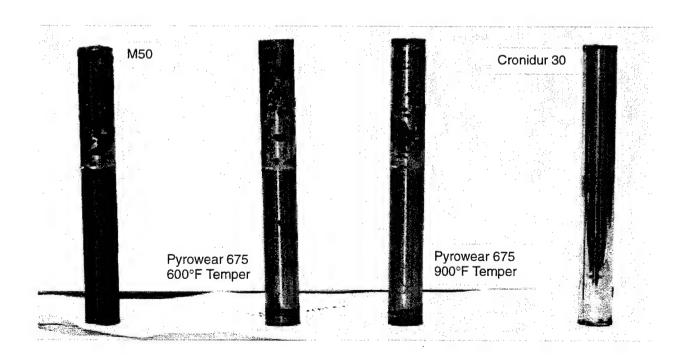
Figure 49. Corrosion Resistance Test: Synthetic Sea Water

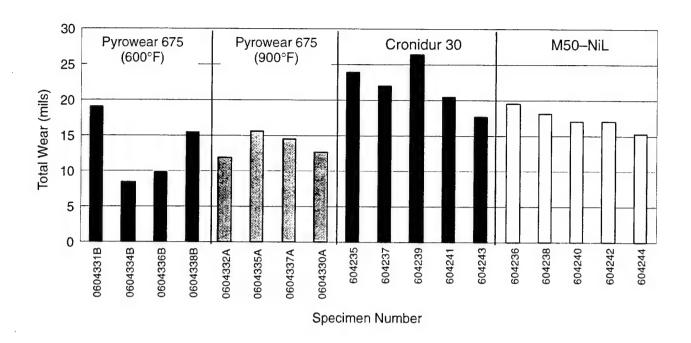
Pyrowear 675, on the other hand, appears to offer greater wear resistance than M50NiL, although it does not appear to be as wear resistant as M50. Table 4 and Figures 50 and 51 summarize the results. The total wear of eight segments of M50 material was roughly 9 mils after similar prior testing. Average Pyrowear 675 total wear was on the order of 13.5 mils for both the 600°F tempered and the 900°F tempered specimens. This is not totally surprising since the Pyrowear 675 case material contains carbides that are visible at 200× magnification, unlike the Cronidur 30 and M50NiL materials where the carbides are difficult to resolve even at 500× magnification. On the other hand, M50 contains large primary carbides from the melting and solidification of the alloy, and large carbides significantly contribute to wear resistance. It is important to note that the rather large spread in Pyrowear 675 wear data may indicate sensitivity to process or microstructural conditions.

Figure 50. Total Wear from Specimens (Results Reported by Falex Corporation)

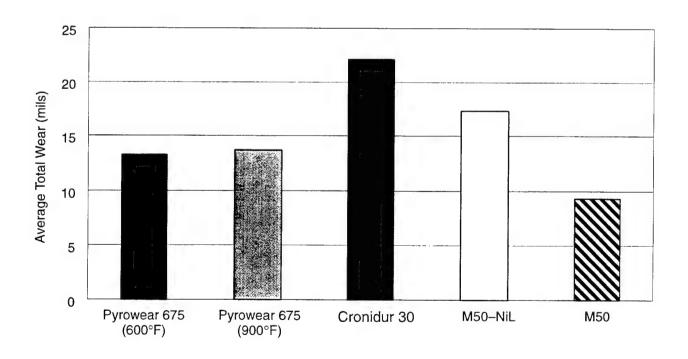
Figure 51. Average Total Wear from Specimens (Results Reported by Falex Corporation)
Compared with Historical Results
